The Platveld Aquifer Study (PAS)

Presentation of Results, concentrating on:

1. The Hydrologic Cycle
2. Bush Encroachment in General
3. Impact of bush Encroachment on Groundwater Resources
4. Case descriptions
5. Groundwater Security = Food Security and Stability

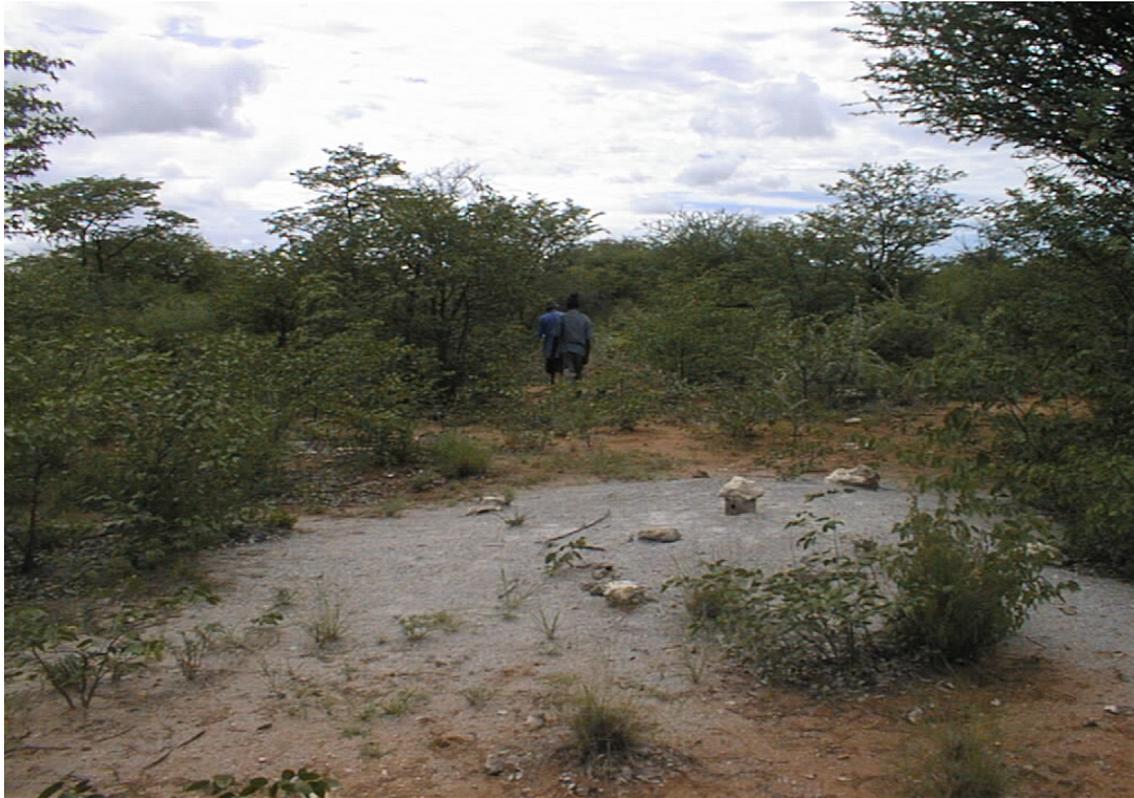
Typical situation

- ▶▶ Dry borehole drilled in densely vegetated bush. Note absence of grass cover.
- ▶▶ (Farm Smythe, February 2004)
